JOURNAL OF THE INSTITUTION OF CIVIL ENGINEERS.

"The Subsidence of a Rockfill Dam and the Remedial Measures employed at Eildon Reservoir, Australia." †

By RUPERT GRENVILLE KNIGHT, M.C., M.C.E., M. Inst. C.E.

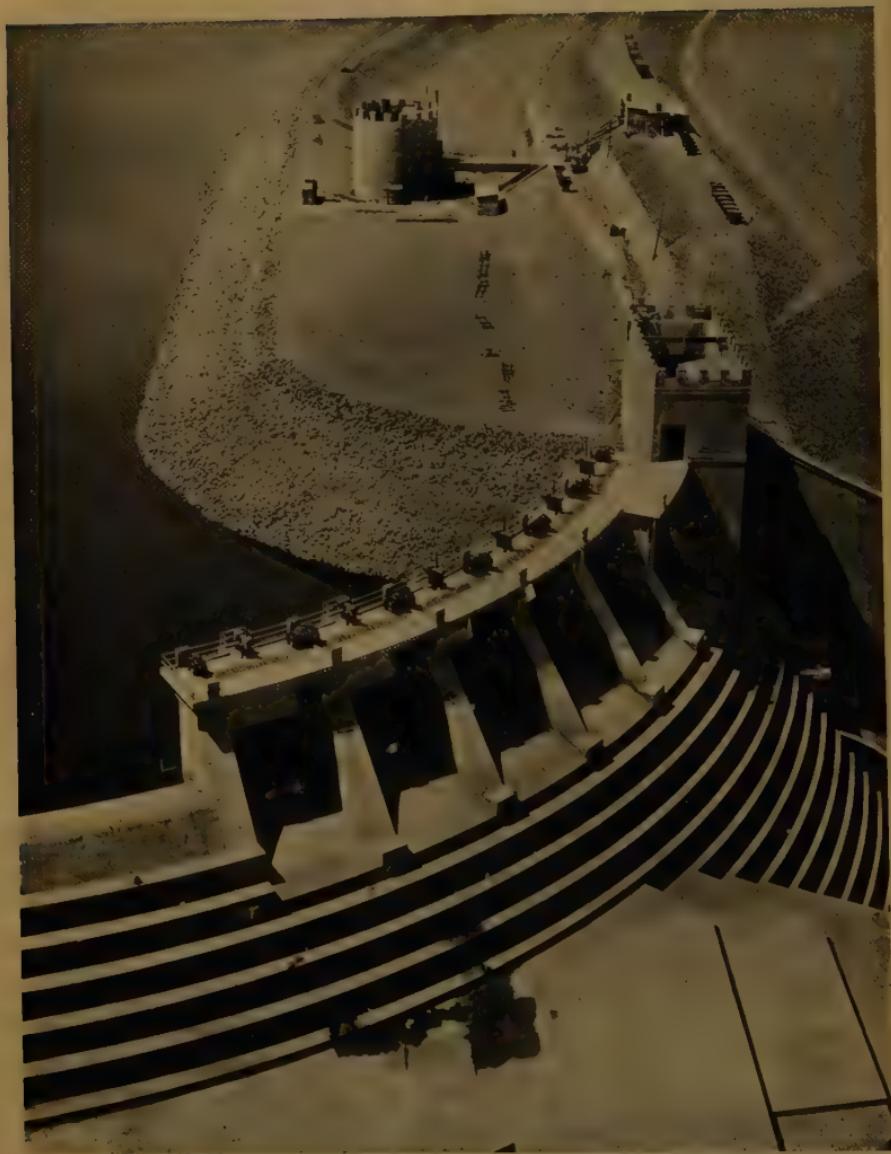
Fig. 7.

WESTERN END OF DAM, SHOWING ROCKFILL AND SURCHARGES, MAIN AND POWER OUTLET-TOWERS, NEW SPILLWAY CONTROL-STRUCTURE, AND EASTERN END OF OLD SPILLWAY-CREST.
